Toronto, Ontario Canada
March 29 – April 3, 2009

Paper C-3-02

BROOKS BRIDGE WATERLINE REHABILITATION

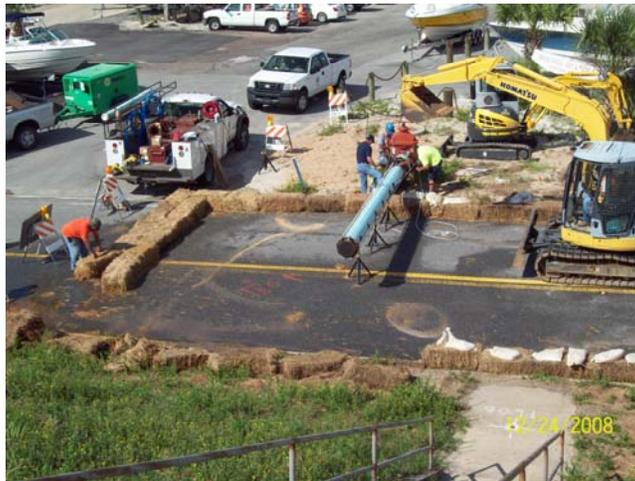
Figure 2. Installation of diffuser to flush the water main.

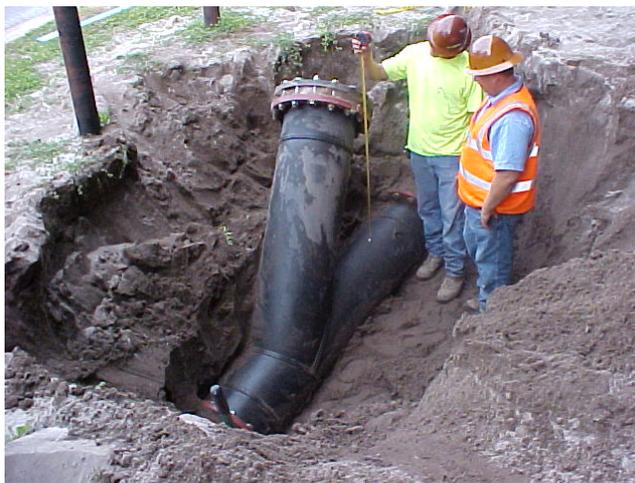
Figure 3. Fabricated wye fitting for launching the video camera.

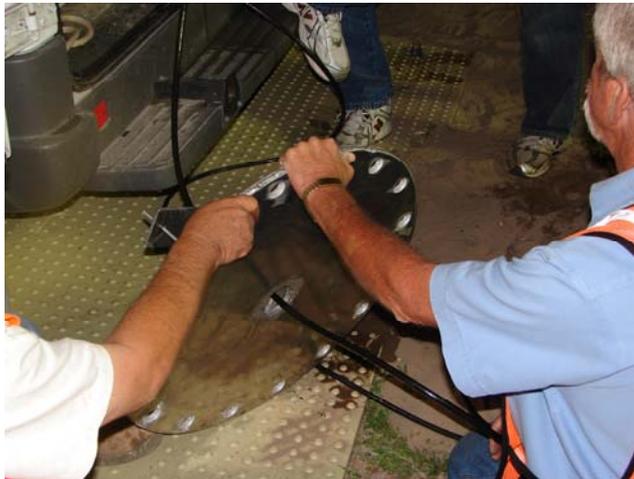
Figure 4. Fabricated plate for wye fitting to allow the camera to operate during flushing.

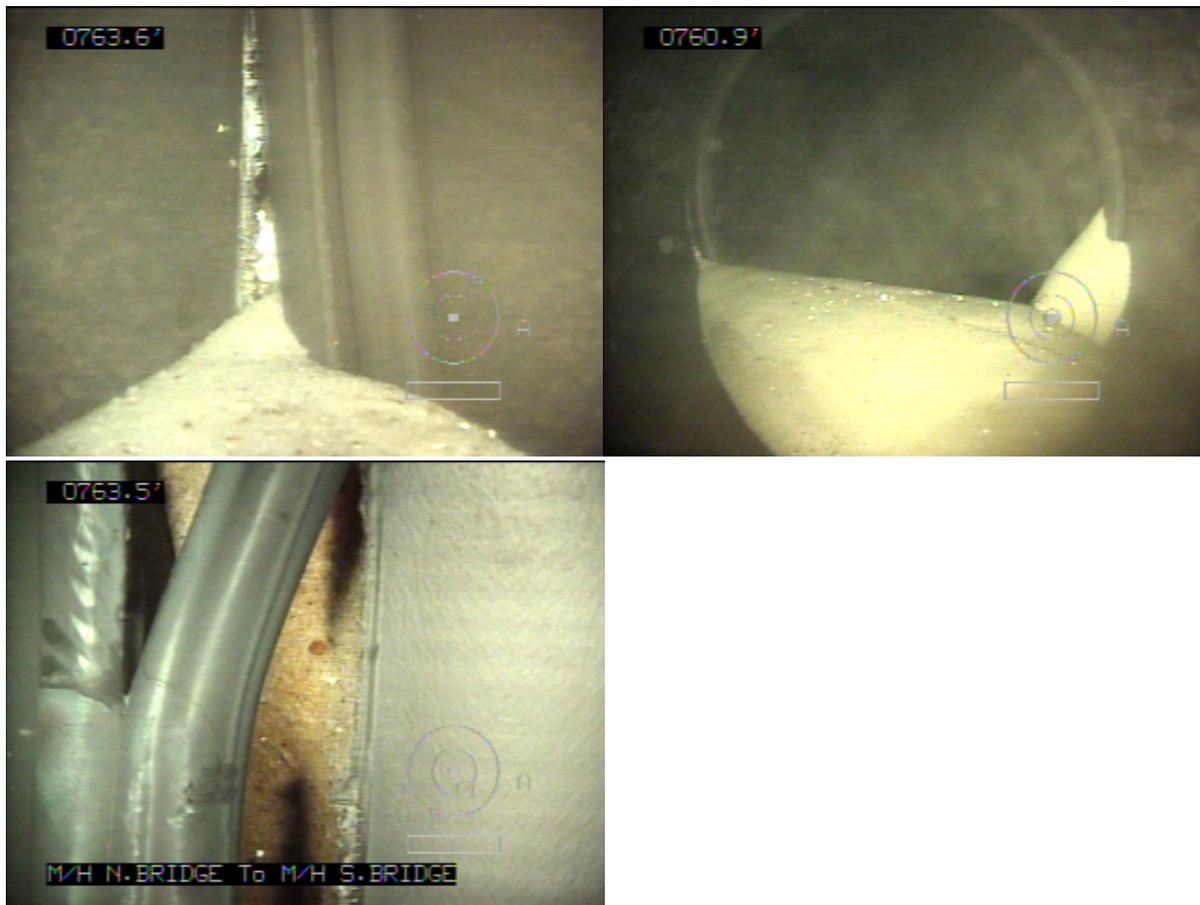
In April 2008, the contractor videotaped the pipe to perform a more detailed assessment of the damaged area and the overall pipe, to confirm that the sleeve is indeed suitable for this application, and to obtain the data required to fabricate the sleeve. For this assessment, the area of the damaged pipe was videotaped both prior to and following the hydraulic flushing. Photos of the damaged area are shown in Figure 5. It was interesting to note that only a small amount of sand had accumulated in the area of the pipe opening since the previous flushing, which occurred approximately seven months prior. In addition,

after the water main was repressurized and flushed, it was noted that several hours had passed before the sand slurry began to re-enter the pipe. It appears that when the pipe is pressurized, an air cavity is formed outside of the tear that temporarily resists the sand slurry from re-entering the pipe.

Figure 5. Photos of the damaged area of the water main.

- The HDPE bead weld at the pipe tear would probably prevent the sleeve from fully expanding and sealing uniformly along the inside of the pipe.
- The water available for flushing the pipe is limited because the Water and Sewer Department must maintain an adequate level in the nearby elevated storage tank.

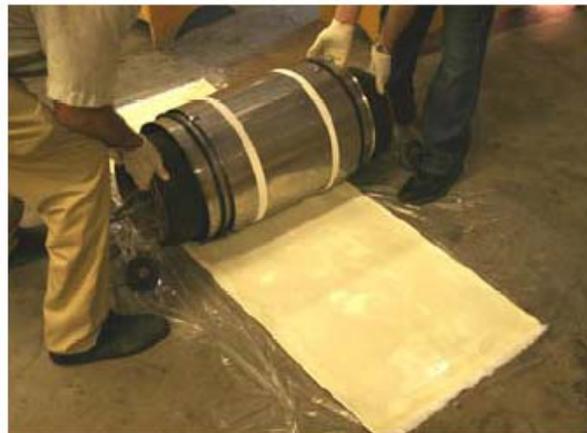
Figure 6. The pipe sleeve and packer being prepared with the epoxy-saturated felt liner (Source: Link Pipe, Inc.)

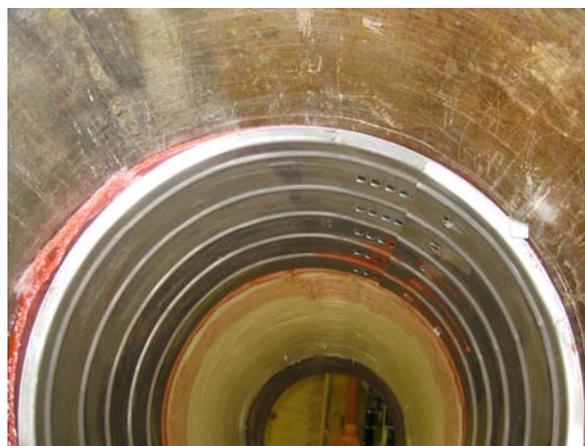
Figure 7. Photograph of the pipe sleeve after installation (Source: Link Pipe, Inc.)

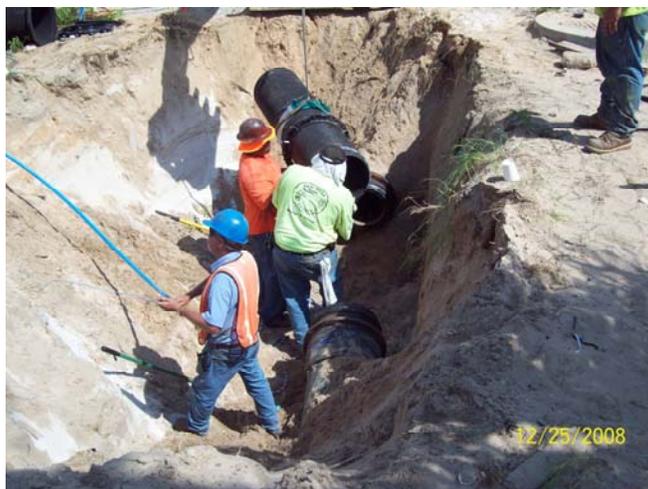
The Water and Sewer Department immediately proceeded with removing the flushing diffuser, the existing tee, and the 10-foot segment of pipe on the island side of the pipe segment (Figure 8). Unfortunately, the bolts securing the mechanical joints of the existing pipe and fittings were severely corroded and very difficult to remove. In addition, a large thrust block encapsulating the tee was encountered, which significantly slowed the progress. By the time the provisions were made for launching the packer, it appeared that the air cavity surrounding the tear collapsed and the sand slurry rapidly entered the pipe and filled the bottom fourth of the pipe. This occurred approximately 5 hours after the pipe was flushed.

Figure 8. The Water and Sewer Department prepare island side of main for launching the sleeve.

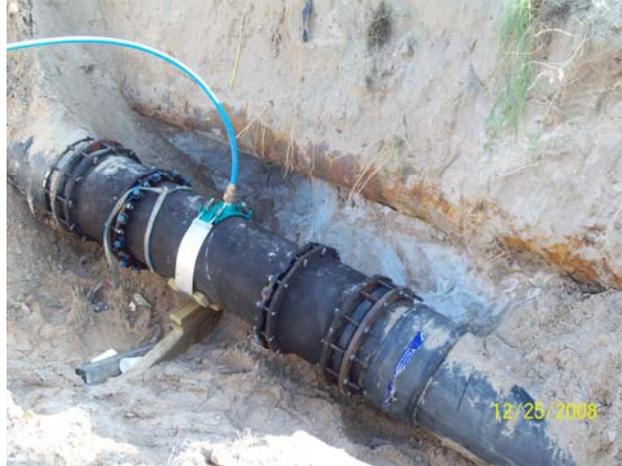
It was decided to temporarily install the previously prepared 10-foot spool piece into the open section so that the pipe could be flushed again, this time in the direction of the mainland through a fire hydrant (Figure 9). The video indicated that the repressurizing and reflushing of the pipe did not prevent the sand from continually entering the pipe as it had done during the Phase 1 assessment. There was enough sand in the pipe around the damaged area that the sleeves could not be installed properly. Therefore, after a total of approximately 12 hours of preparation, the operation was suspended for the day.

Figure 9. Temporary spool piece on island that will be removed for launching the sleeve in the future.
