Toronto, Ontario Canada
March 29 – April 3, 2009

Paper C-3-02

BROOKS BRIDGE WATERLINE REHABILITATION

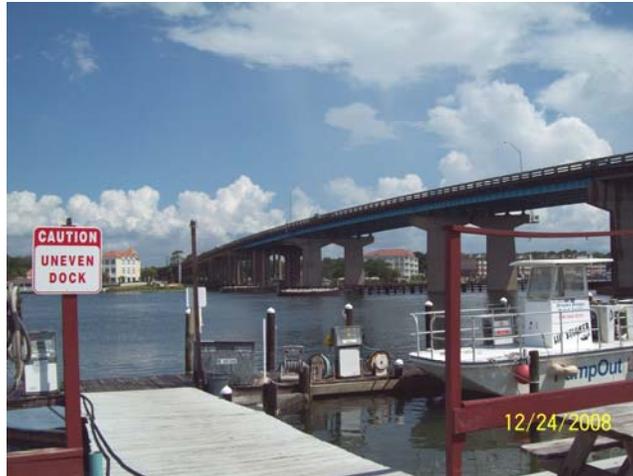
Figure 1. General area where the Brooks Bridge Water Main crosses the Santa Rosa Sound , perspective from the island looking toward the mainland.
